Manhole Inspection Summary

Manhole # S15QQ1026MH

Insp Date: **11/6/06 2:27 PM**

Location Address: **5018 YELLOWWOOD AVE**

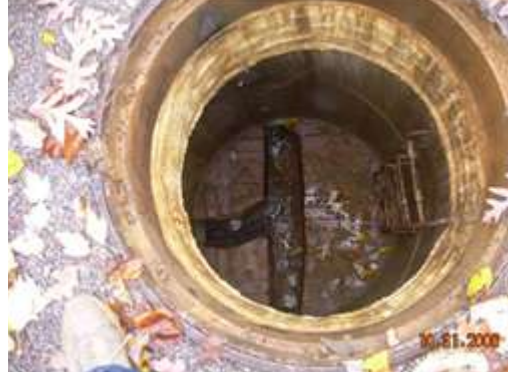
Top View

Evidence of surcharge - Bench debris.
Channel debris.

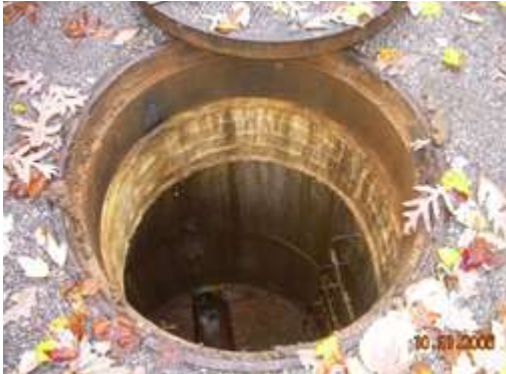
Defect

☒ **Leaks**

Infiltration: ☐ None ☒ **Joint** ☐ Cracks ☐ Mortar ☐ Roots ☐ Wall

Frame leaks. Adjustment infiltration.

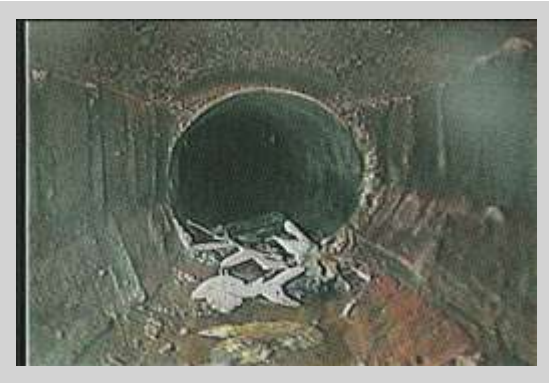
8 in. Circular Gravity Sewer Pipe Out @ 12 O'Clock

Deposits: ☐ None ☐ Mud ☐ Sludge ☒ **Debris** ☐ Grease

Silt Depth: **1** (in.) Deposits Extent: **Light**

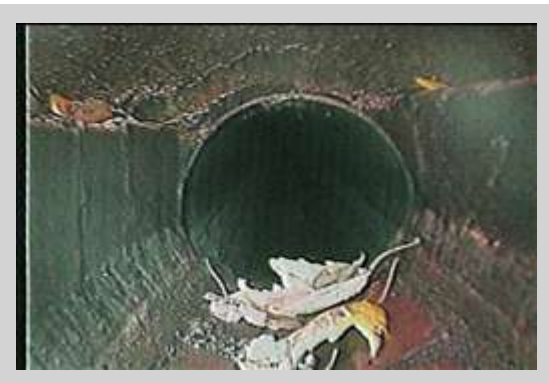
8 in. Circular Gravity Sewer Pipe In @ 6 O'Clock

Deposits: ☒ **None** ☐ Mud ☐ Sludge ☐ Debris ☐ Grease

Infiltration: **None** Pipe Seal Cond: **Unknown**

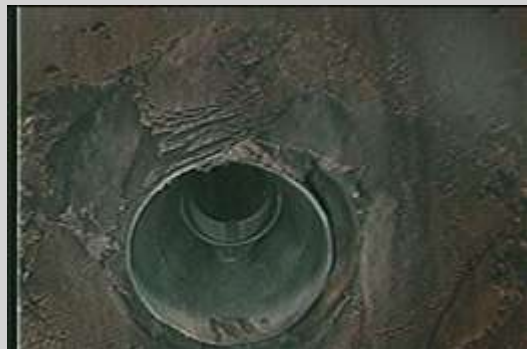
Pipe In @ 9 O'Clock

Deposits: ☒ None ☐ Mud ☐ Sludge ☐ Debris ☐ Grease

Infiltration: **None**

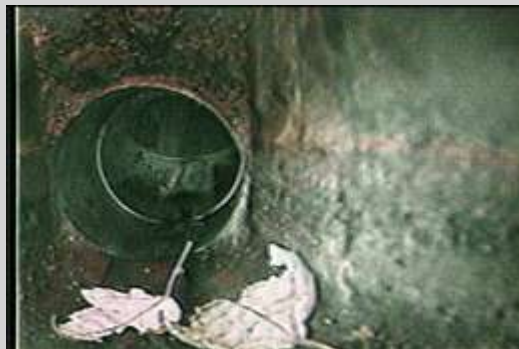
Drop In @ 9 O'Clock

Drop: **Outside** Rod and Bar

Drop Condition: **Open**
